Increasing the accessibility and safety at the cyclist/pedestrian tunnel at Enschede Kennispark

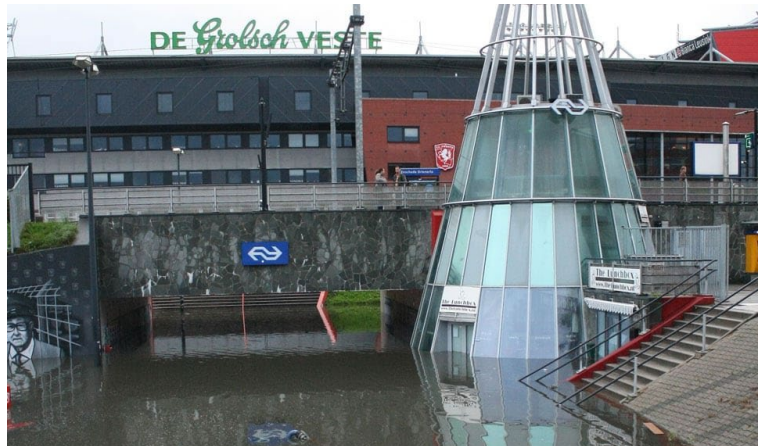
The underpass at the station 'Enschede Kennispark' frequently floods during extreme rainfall events (figure 1). Furthermore, the traffic situation is experienced as dangerous due to the mixed traffic flows and poor visibility. These issues have a large impact on the safety and accessibility of the tunnel for daily users.

The tunnel can flood up to 1 meter during heavy rainfall events. The tunnel is located at the end of the sewer system. Therefore, during heavy rainfall, is the sewer system at that location full due to the rain upstream. This results in the water flowing towards the tunnel, where the storage capacity is insufficient.

Figure 1: Underpass Enschede Kennispark flooded.
