Sewer condition assessment using ground penetrating radar and multitemporal thermal infrared imagery

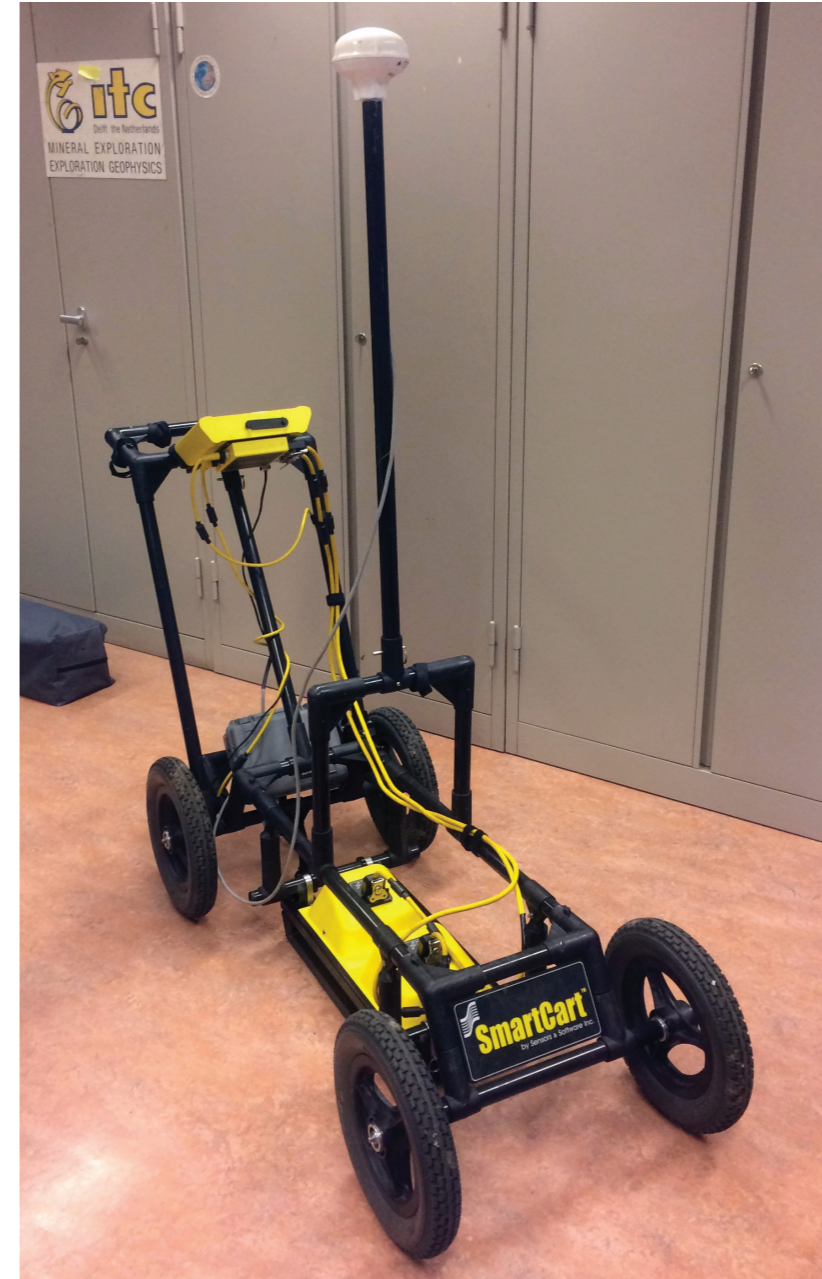
Figure 1. Sensors and software GPR Pulse EKKO Pro mounted with 500MHz transducers, and possibility to mount 100MHz antennas. GPR lines are collected perpendicular and parallel to the direction of the rad.

Reduction in the monitoring frequency and aging of the sewer system lead to the generation of cracks or failures in the sewer pipe. Such failures can lead to water leaking out of the sewer pipe into the surrounding soil or underground soil erosion developing into underground voids. These underground voids usually go undetected, and may cause the surface above them to collapse thereby developing sinkholes. In this research it is proposed to use ground penetrating radar (GPR) (Figure 1) and thermal infrared (TIR) imagery (Figure 2) to observe the environment surrounding the pipe.

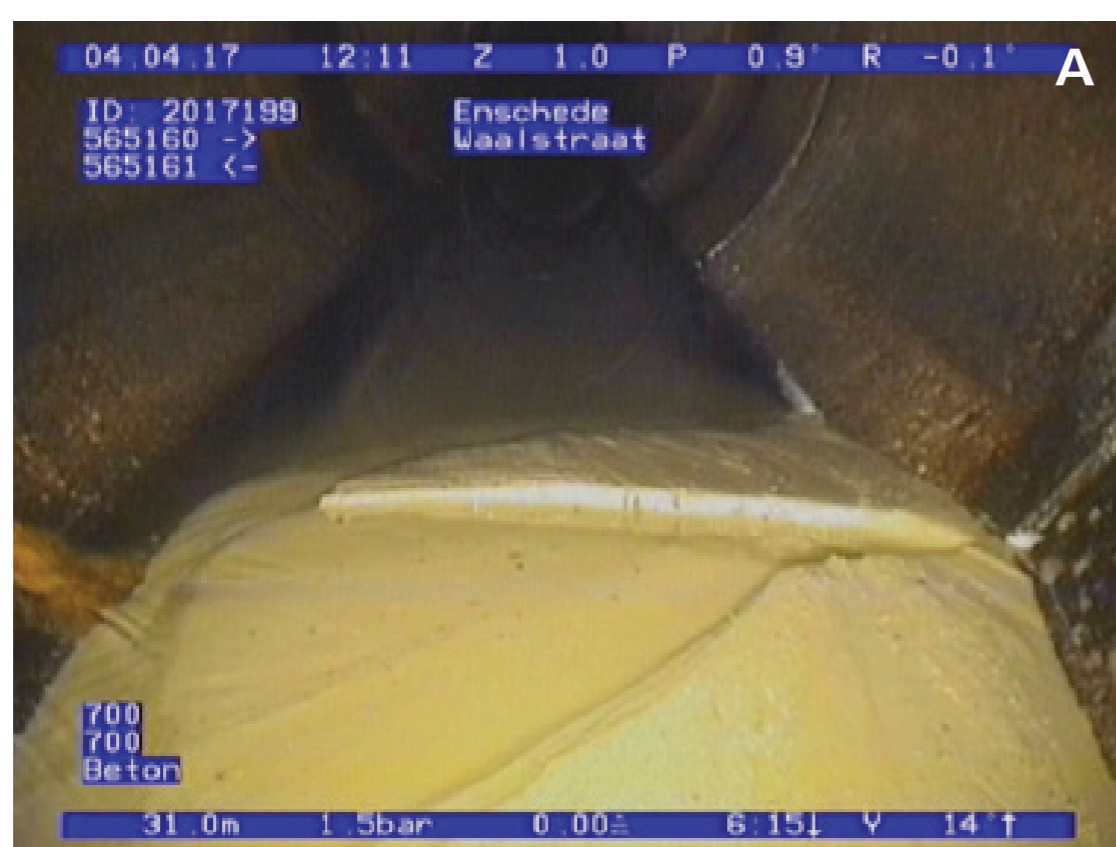
Figure 3. a) CCTV image acquired by the Municipality of Enschede, it can be clearly seen infiltration of sediment from the road into the sewer pipe. b) Optical image acquired with optical game camera Moultrie m-series showing the test site in Waalstraat. Notice the deformation on the road (red circle) caused by infiltration of sediment into the sewer pipe. c) Thermal infrared image acquired on February 15 2020 at 16:15 hours.

At the current stage of the study, measurements are being taken in Waalstraat, Enschede, The Netherlands. The test site was selected in collaboration with the municipality of Enschede who have run a CCTV inside the sewer system and identified sediment entering into the pipe (Figure 3a) and causing deformation in the road surface (Figure 3b).

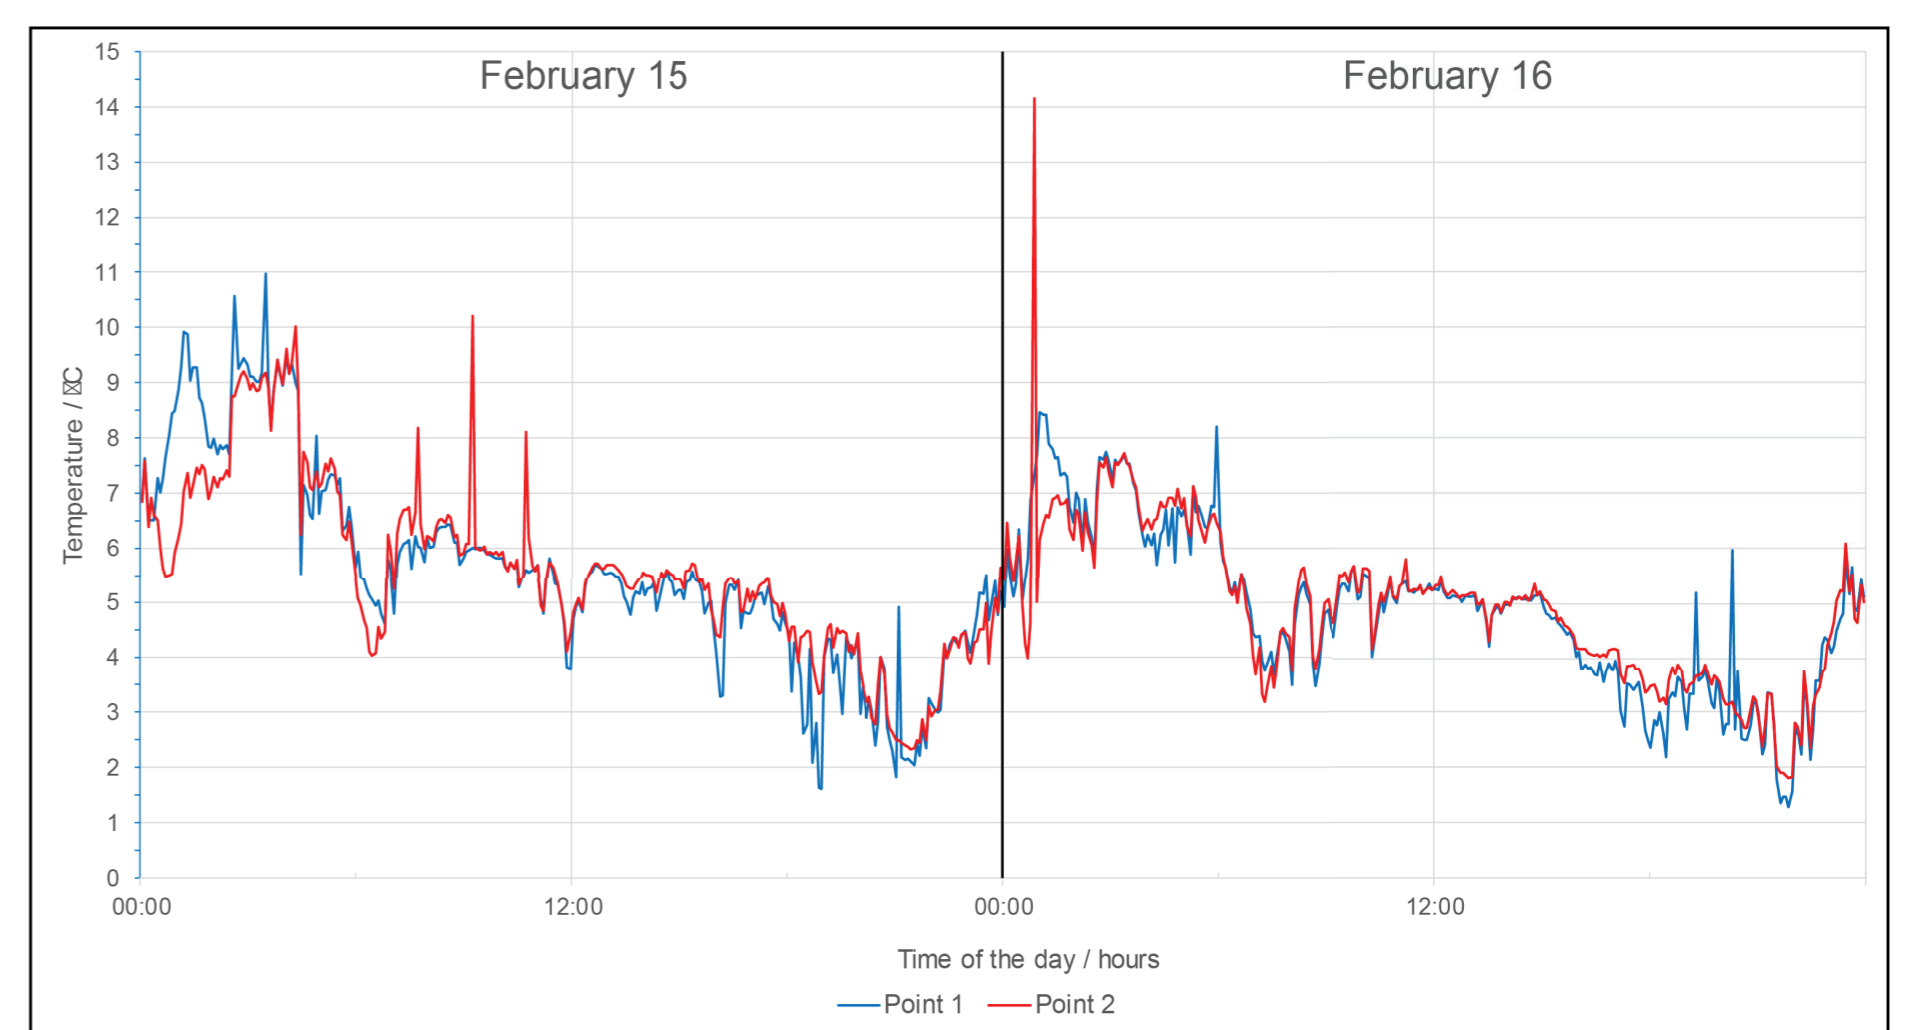
Figure 4. Surface temperatures of 2 different points on Waalstraat road. Temperature taken from thermal infrared imagery acquired every 5 minutes between 15 and 16 February 2020. The abrupt changes in temperature are due to turbulence in the Convective boundary layer that presented high turbulence due to the effect of Storm Dennis.

The proposed setup will allow us to observe changes in diurnal surface temperature cycles through time with the use of TIR images (Figure 3c & Figure 4). GPR data will show differences in return time of emitted electromagnetic waves travelling in the underground layer (Figure 5). By combining these two techniques it may be possible to localize increase in soil moisture (due to water outflow from the pipe), or areas with voids.
