Stability issues in Pd/B₄C multilayers

Ch. Morawe¹, R. Supruangnet^{1,2}, J-Ch. Peffen¹

¹ ESRF, Grenoble (France)

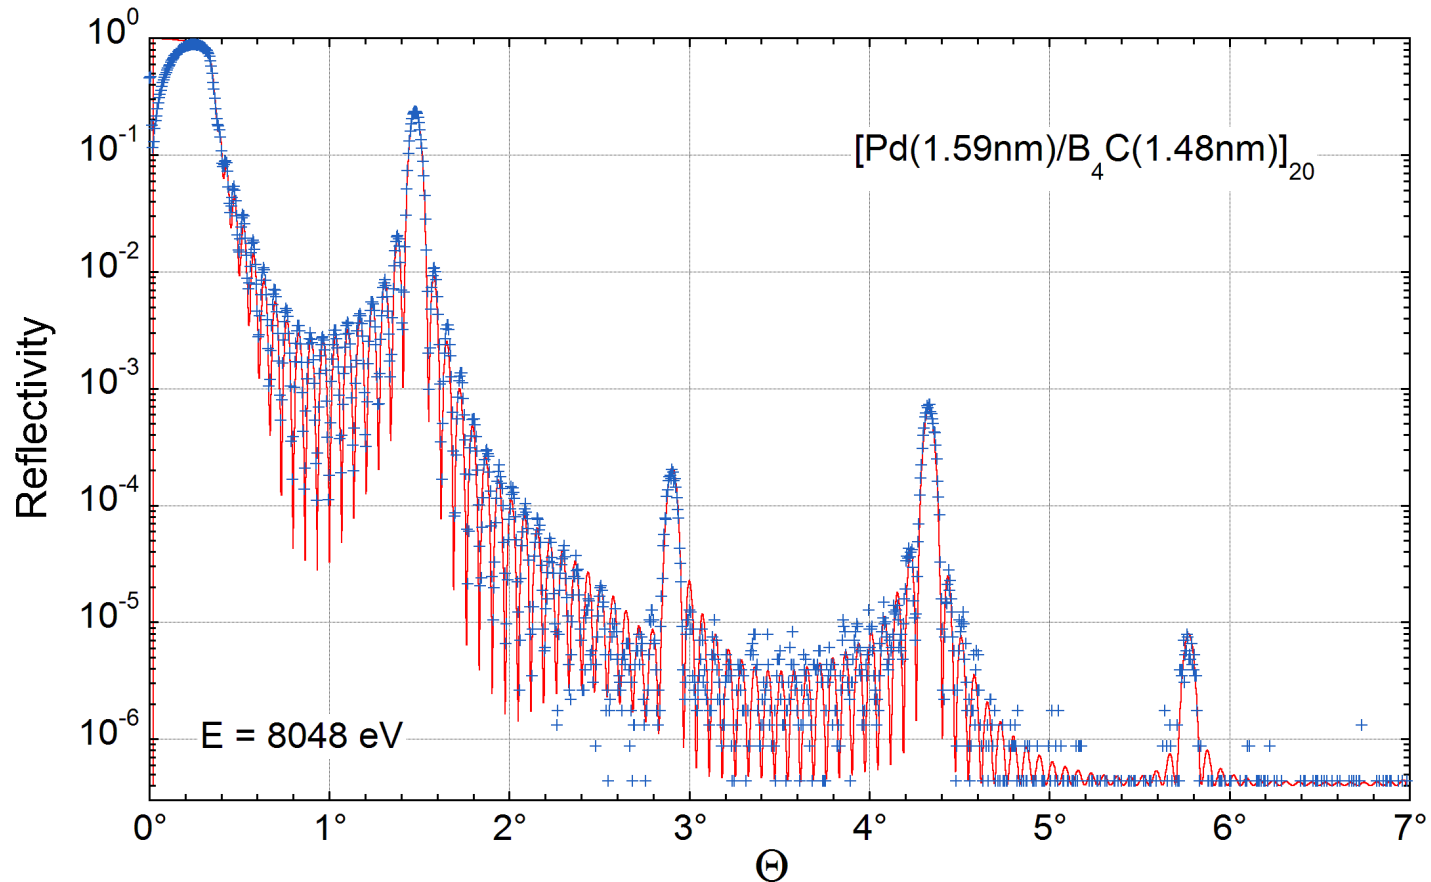
Why Pd/B₄C ? – Initial observations

- Attractive optical properties of Pd at $E \leq 24$ keV
- Strong materials contrast, sharp interfaces $\sigma = 0.21 \dots 0.25$ nm

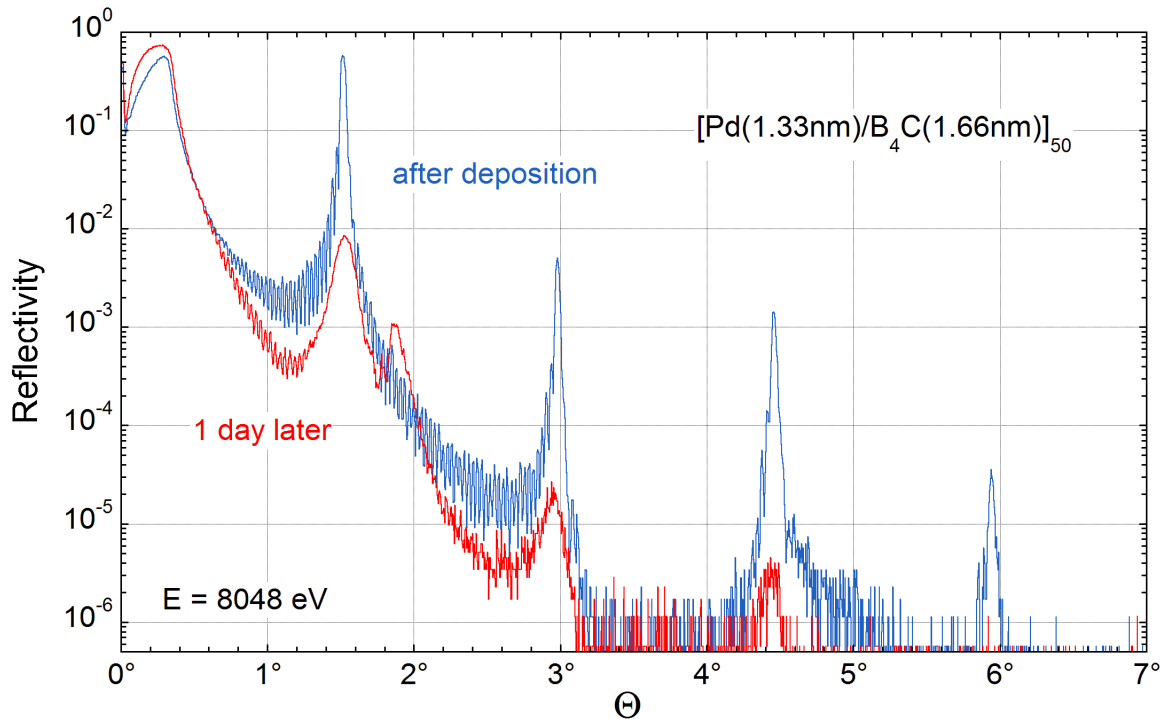
Further observations

- Alteration for d-spacings < 4 nm
- Rapid formation of stains + particles on surface → disappear later !
- Significant reflectance loss + peak shift after 1 day in air !

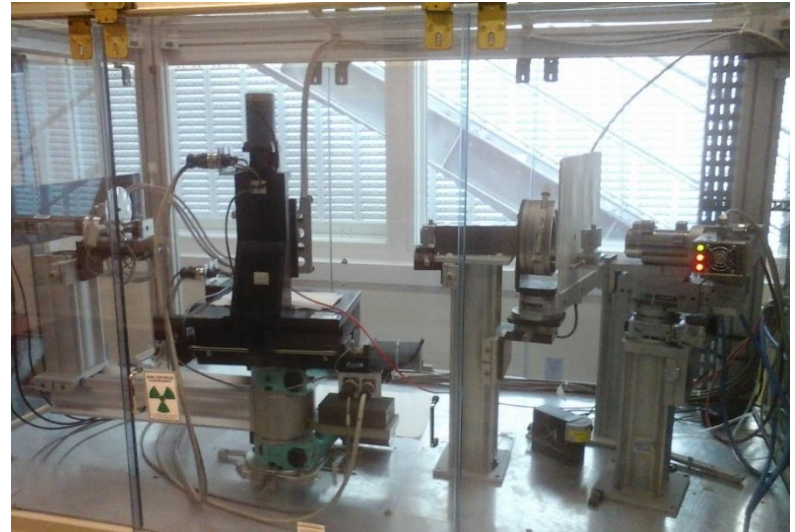
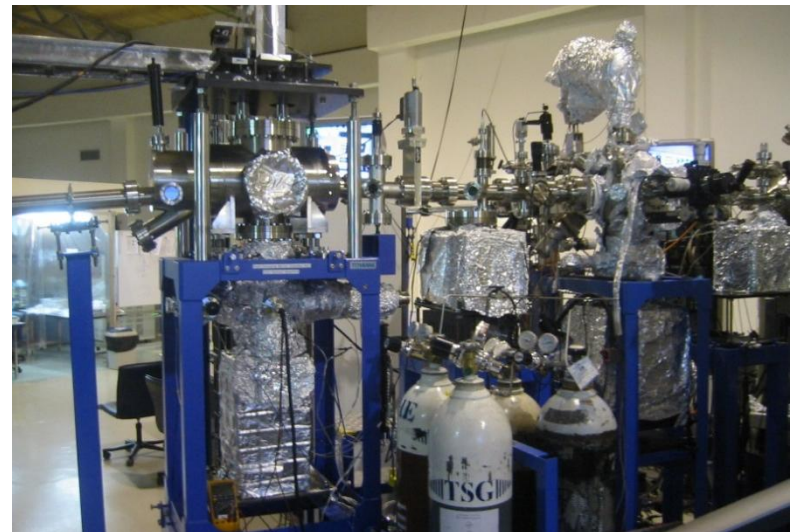
Photoemission electron microscopy (PEEM)

- BL3.2Ub (SLRI – Thailand) at B K-edge
- LEEM III imaging analyzer (ELMITEC)

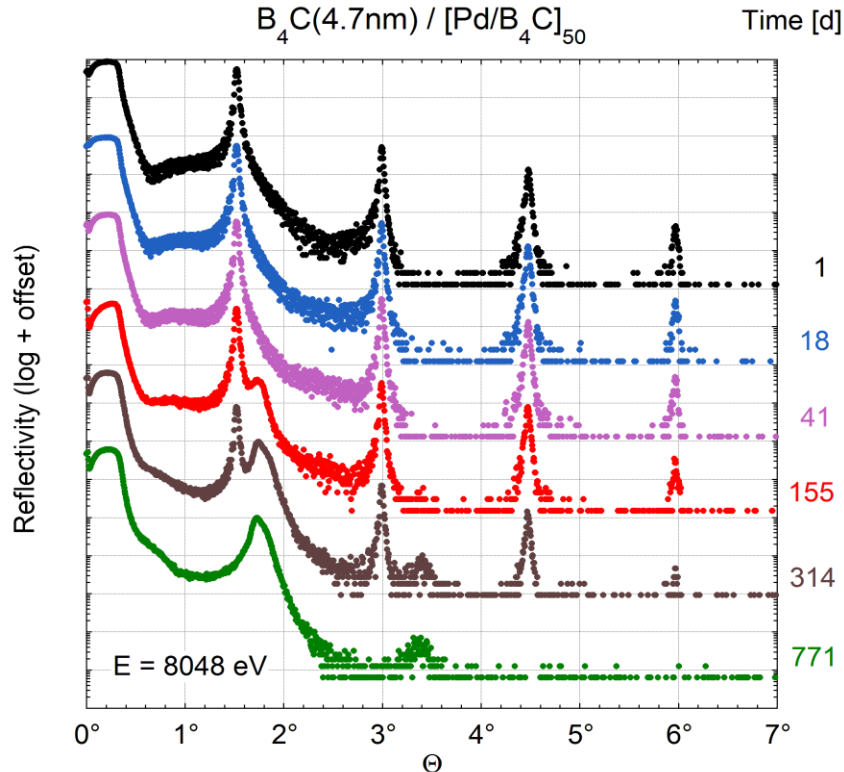
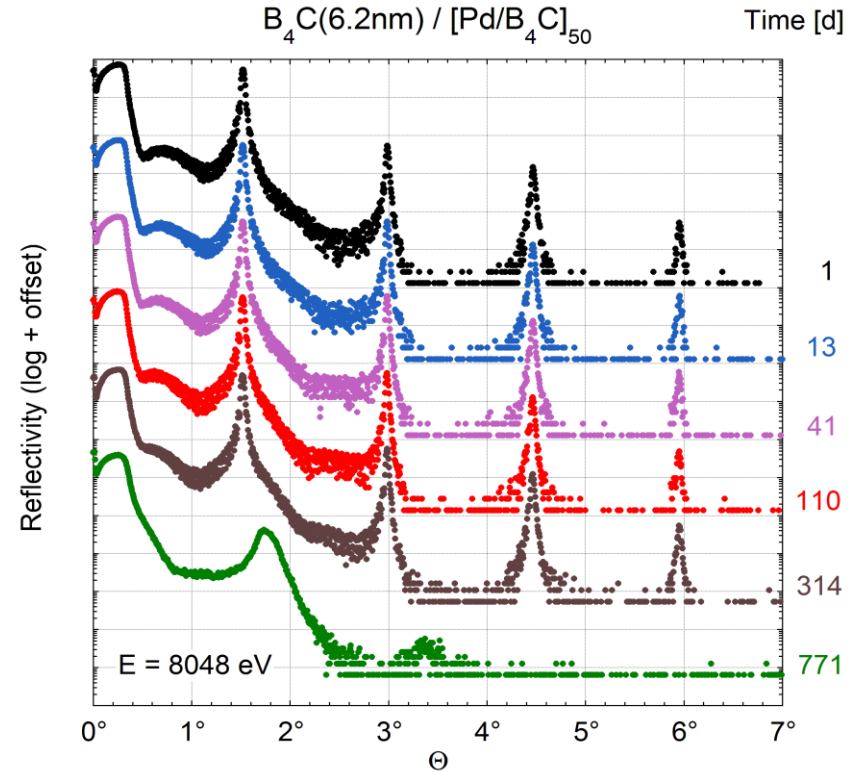
X-ray reflectivity

- ML sample series with cap layer: $B_4C(\text{var})/[Pd(1.35\text{nm})/B_4C(1.65\text{nm})]_{50}$
- Degradation slowed down ($>1\text{y}$), but not stopped
- ML period reduction from 3.0 nm to 2.3 nm
- Old peak sharp, new peak broad \rightarrow co-existence of laterally separated phases

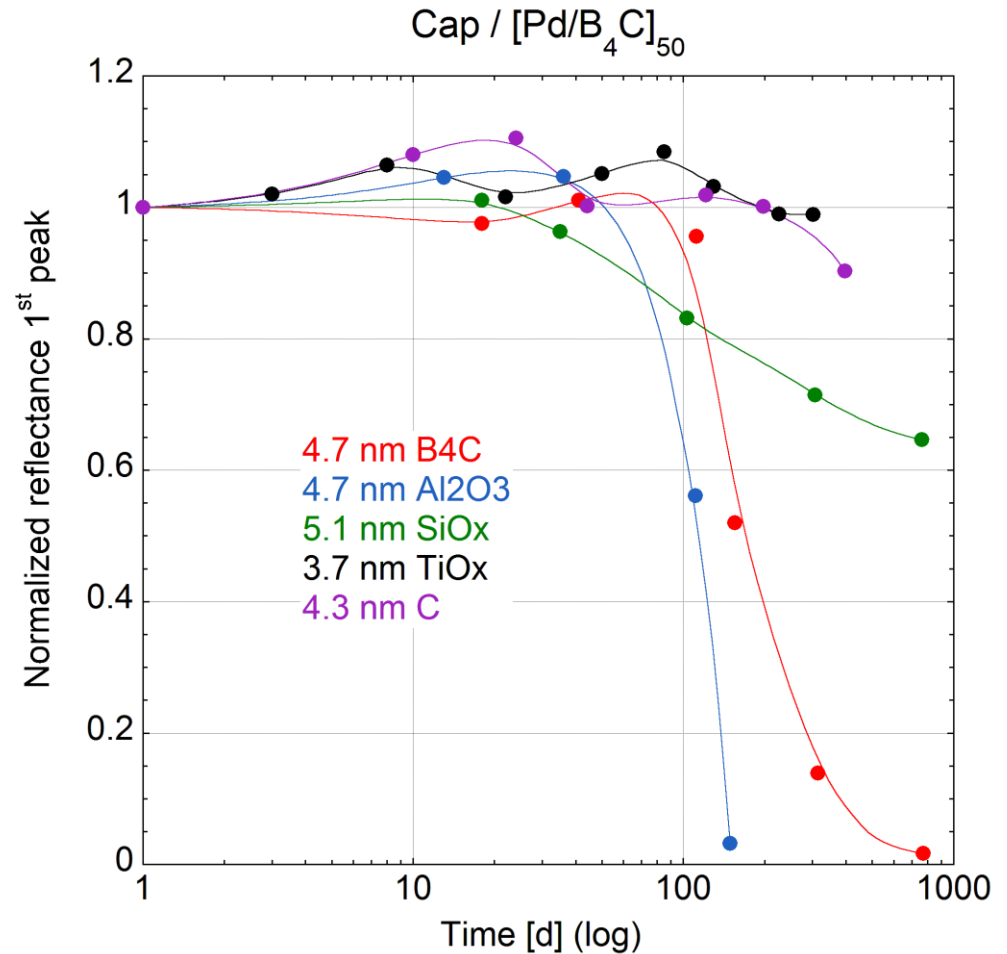
X-ray reflectivity

- Further cap layer materials: B_4C , Al_2O_3 , $Si(O_x)$, $Ti(O_x)$, C
- Variable cap layer thickness (wedge)
- Similar reflectivity patterns and rapid drop after 100 d for B_4C and Al_2O_3
- Slower decay for $Si(O_x)$
- Moderate reflectance loss for thin (< 4 nm) $Ti(O_x)$ and C cap layers
- No degradation on Pd/ B_4C ML in vacuum !

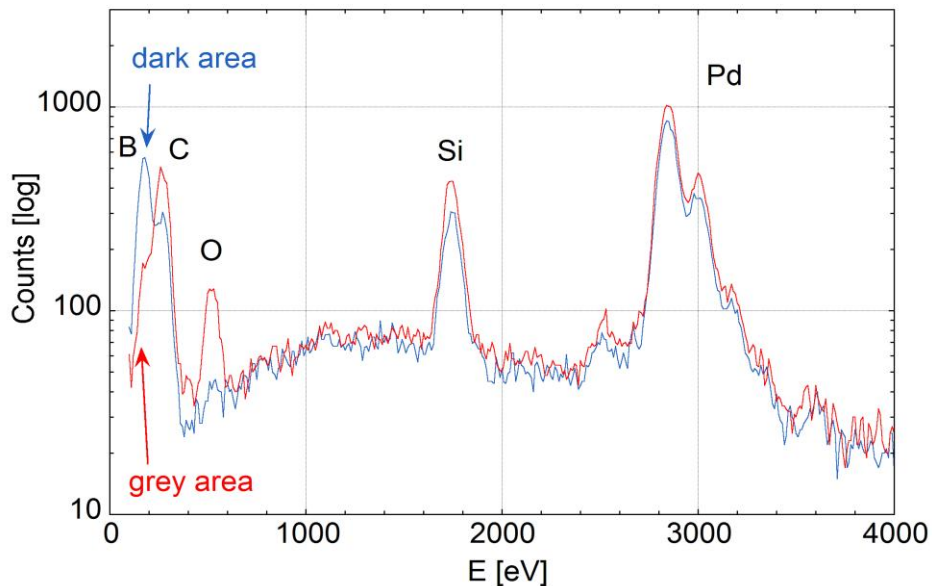
SEM imaging + EDX

- $B_4C(5.1nm) / [Pd(1.31nm)/B_4C(1.34nm)]_{150}$
- 2 months stored in air
- Defects containing particles (or holes)
- Surrounded by grey halos
- B + C in dark zones
- B depletion and O inclusion in grey areas

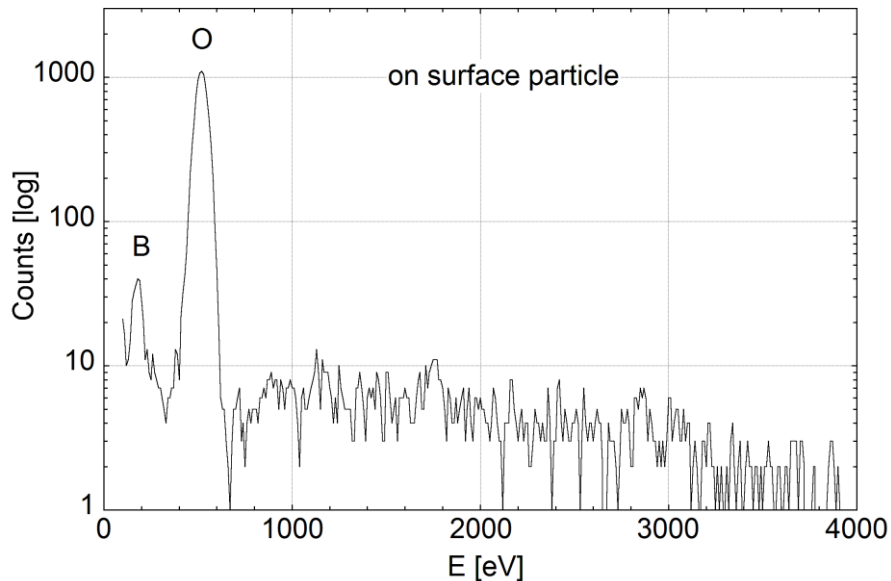
SEM imaging + EDX

- $B_4C(2.4nm) / [Pd(1.33nm)/B_4C(1.66nm)]_{50}$
- 2 months stored in air
- Large insulating surface particles
- Spectra on particle
- B and O signals only
- Evidence for B_2O_3 crystals

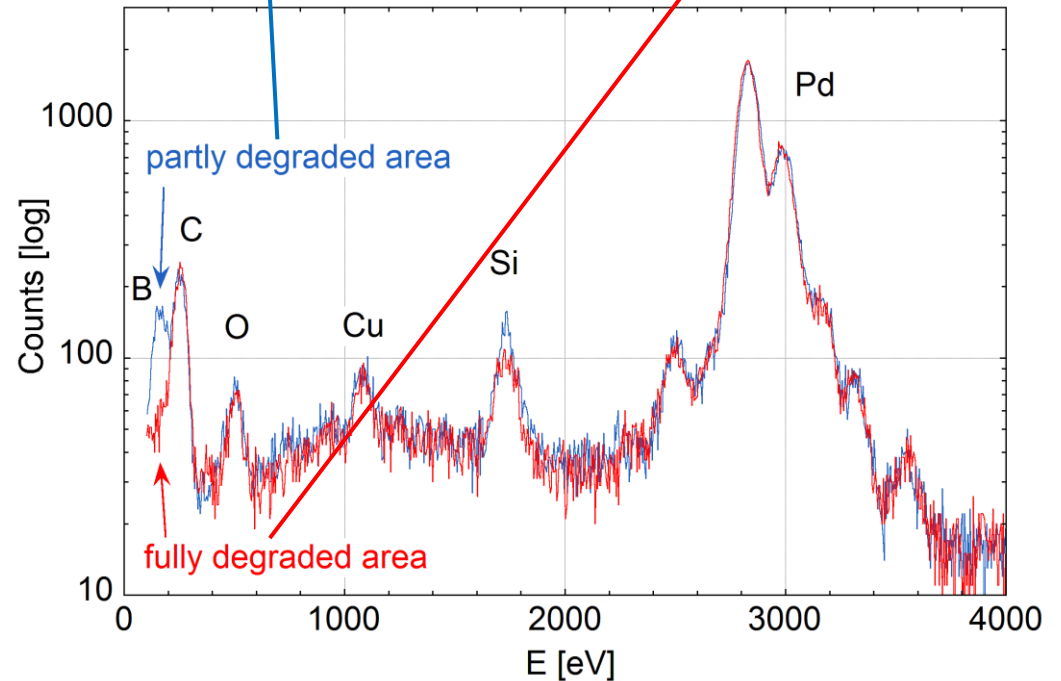
TEM EDX

- $B_4C(4.2\text{nm}) / [Pd(1.33\text{nm})/B_4C(1.65\text{nm})]_{50}$
- 6 months stored in air
- Probing local cross section
- B depletion in degraded areas
- Similar spectra compared to SEM data
- Single layers not resolved

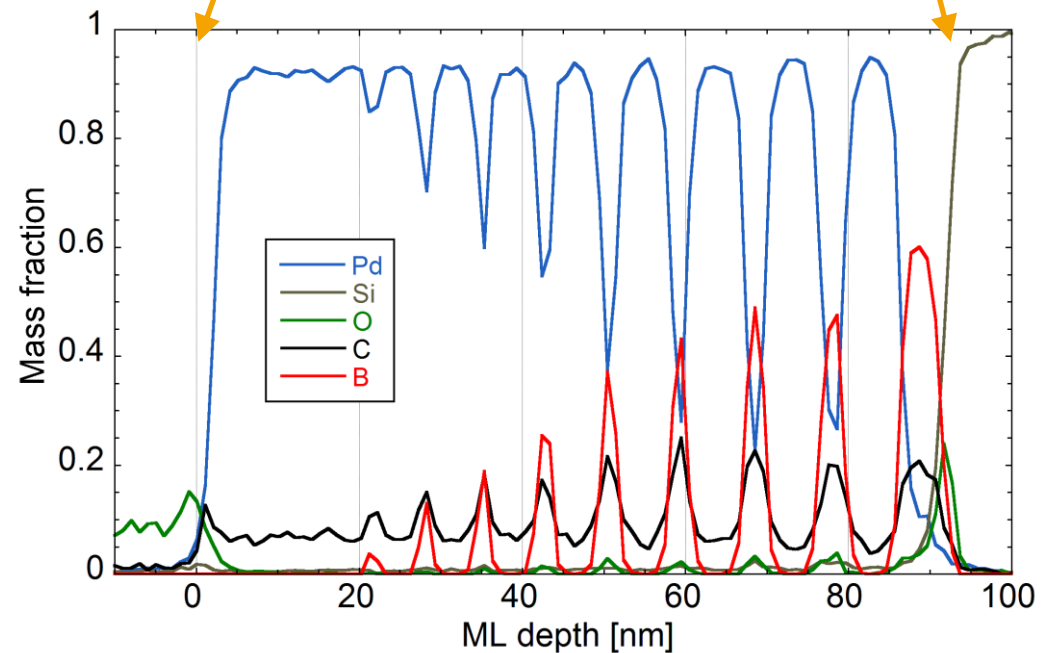
TEM EDX

- Non-periodic ML with variable $t(\text{B}_4\text{C})$
- $\text{B}_4\text{C}(0.5\text{nm}) / [\text{Pd}(4.0\text{nm})/\text{B}_4\text{C}(6.5\text{-}1.0\text{nm})]_{12}$
- 3 years stored in air
- Scan across ML depth
- Pd signal \approx deposited quantities
- B signal appears for $t(\text{B}_4\text{C}) > 1.5\text{ nm}$ increases with ML depth down to Si
- C fraction saturates earlier
- O content scales with B signal
- Upper B_4C layers disappeared
- Lower B_4C layers oxidized

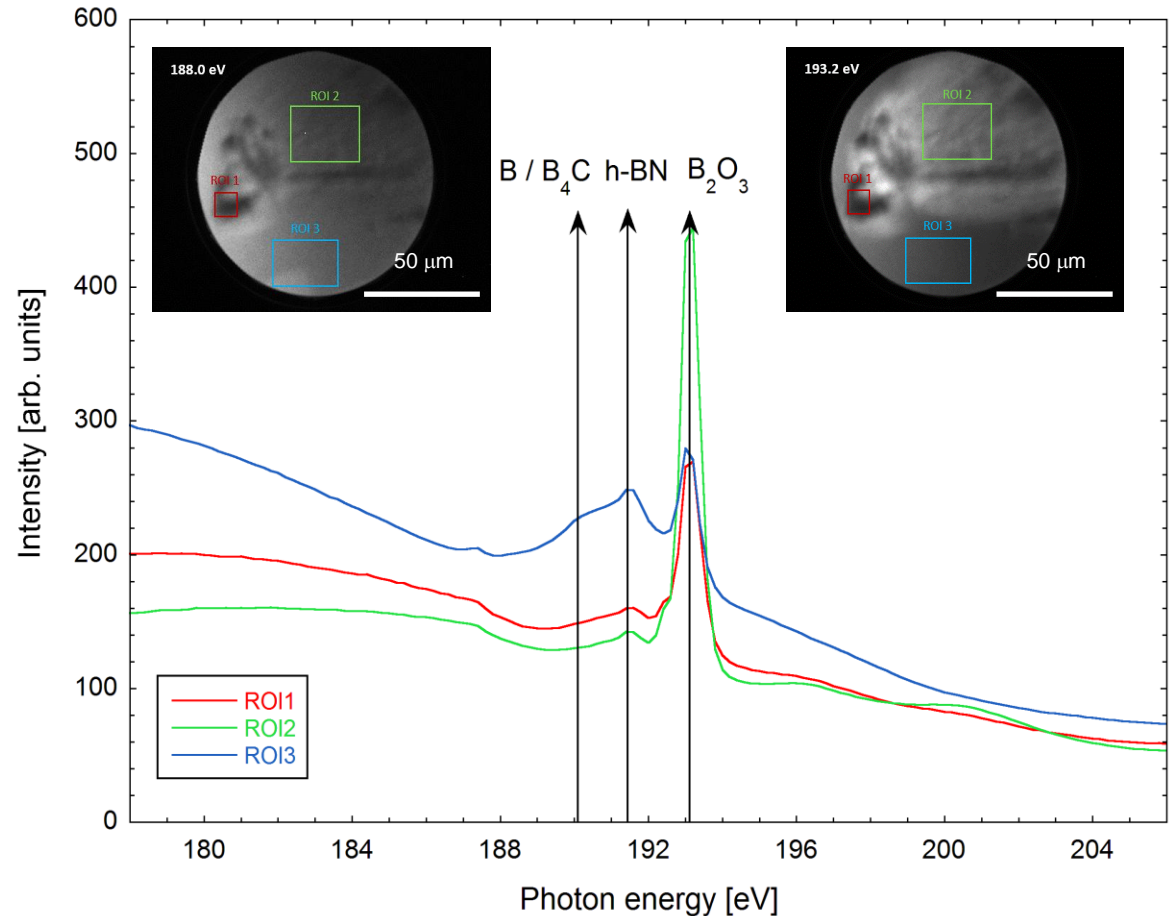
PEEM imaging spectroscopy

- $B_4C(2.4nm) / [Pd(1.33nm)/B_4C(1.66nm)]_{50}$
- 5 weeks stored in air
- Showing surface crystals
- Chemical shift of B $K\alpha$ peaks
- High spatial resolution
- Sensitive to low-Z elements
- B_2O_3 like compounds on crystals
- B / B_4C away from crystals
- Confirms x-ray and EDX data

- Oxygen enters through defects, drains Boron to form B₂O₃
- B₂O₃ crystallizes at surface, then evaporates or dissolves in air
- Boron depletion and d-spacing reduction in affected areas
- ML order severely disturbed
- Time scale: hours → days (unprotected MLs)
- Protection layers: life time → years (→ stable in vacuum)
